Moving beyond compliance:

Coral Bay Nickel Corporation's Rehabilitation of Tailings Storage Facility 1

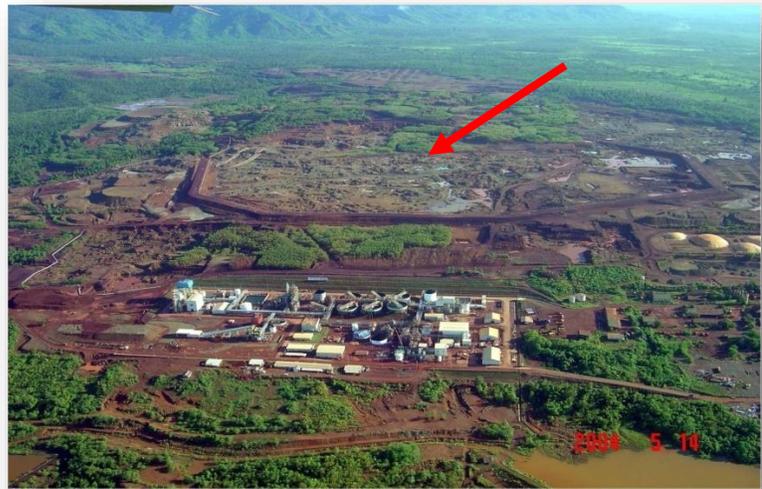
Tailings Storage Facility #1 (TSF1) built on a mined-out area in 2004.

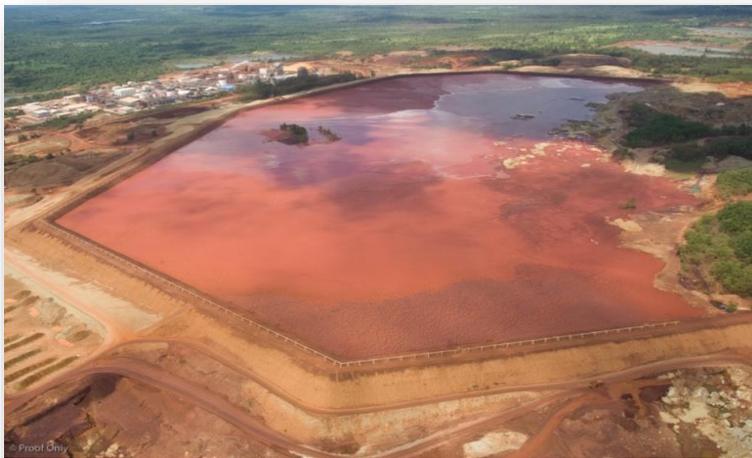
2008: Embankment has been raised to the 68 MASL level and 3.7M DMT of tailings stored.

The embankment was raised to 68 meters above sea level and 3.7M dry metric tons (DMT) of tailings stored after five years of operation. Its slurry characteristic was suggestive of an unproductive substance incapable of growing any life-form.

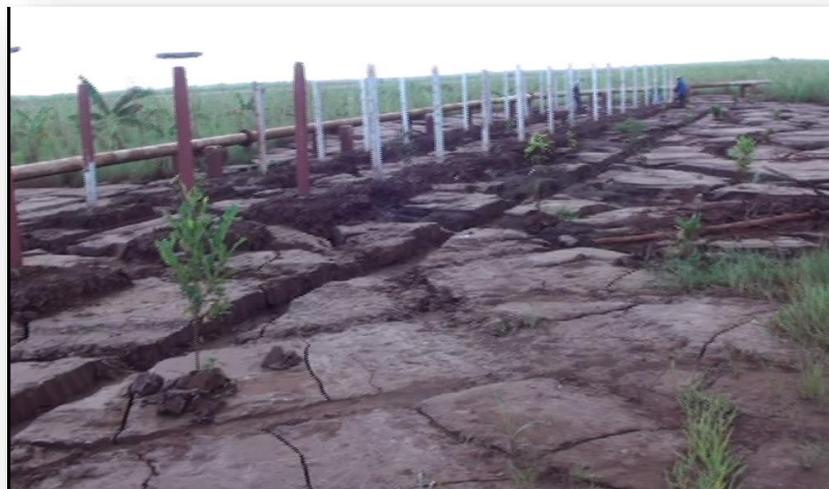
The barren and cracked dam surface

Despite their optimism, several challenges confronted the company during actual implementation and these were much about covering the whole area with nutrient-rich top soil so plants may grow. The task was almost impossible considering the soft and weak surface that could not hold heavy equipment and burrowing, yet in employing the following strategies, CBNC was ready to spread the green.

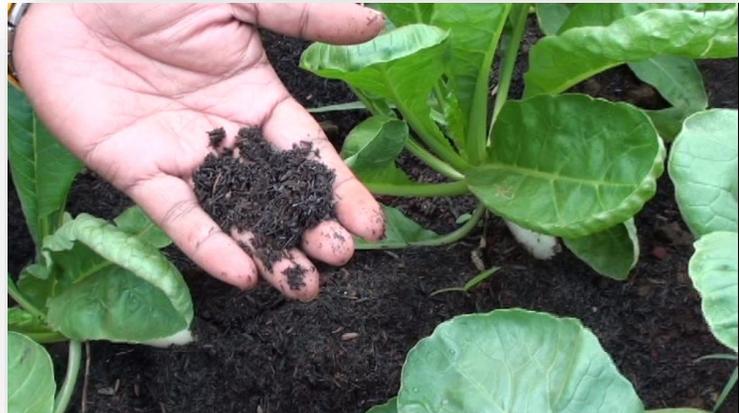
Carbonized rice hull was introduced to nourish plants

Fertile and nutrient-rich soil planting media containing a mixture of top soil, vermicompost and carbonized rice hull was used. This soil media was placed in small (6-inch by 8-inch) plastic pots where the vines and grasses were grown for 3-4 weeks in sturdy condition prior to transplanting.

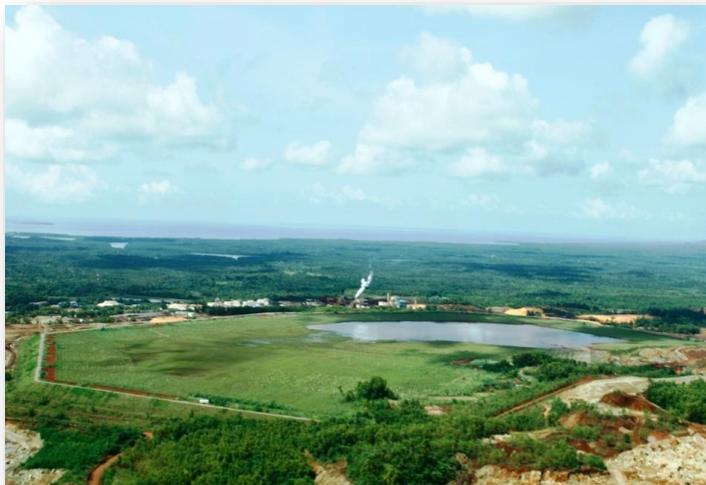
October 2012: TSF# 1 After 20 months of rehabilitation activities at the surface and slopes

Species of vines, grasses and herbs such as *Brachiaria Humidicola*, *Stylosanthes seabrana*, *Centroema pubescens*, wild sugar cane (*Saccharum spontaneum*), napier grass (*Pennisetum purpurium*), banana and elephant ear (*Xanthosoma robustum*) were found after trial planting. Diverse other grasses and vines whose seeds or roots were naturally present in the soil used also sprouted and are growing naturally and now cover the tailings soil.
